AN ASSESSMENT OF ABANDONED MINES IN NORTHERN SASKATCHEWAN (YEAR 2)

GULCH MINE ADIT-URANIUM CITY AREA
SEPTEMBER 28, 2001

MAY, 2002

PREPARED FOR:
SASKATCHEWAN ENVIRONMENT

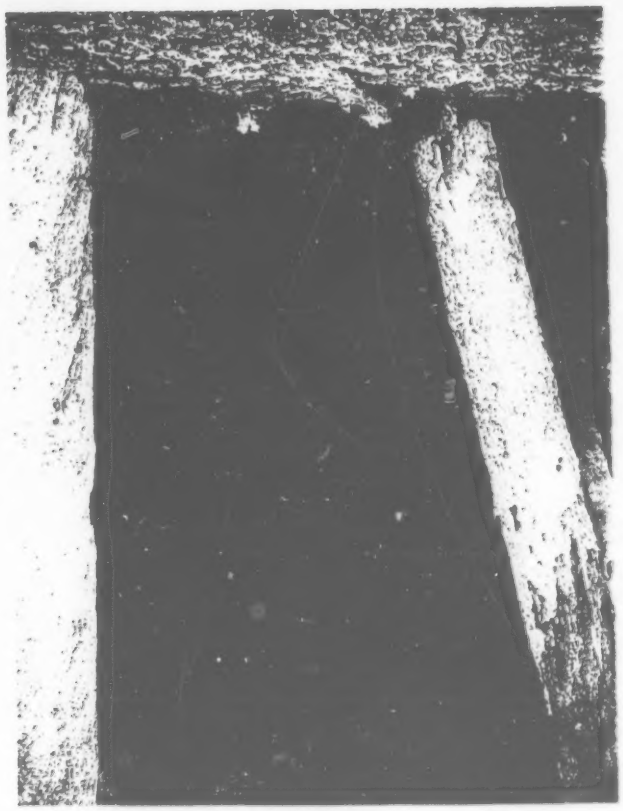
Photo 6.6-5 Adit Closeup-Homer Yellowknife
September 28, 2001

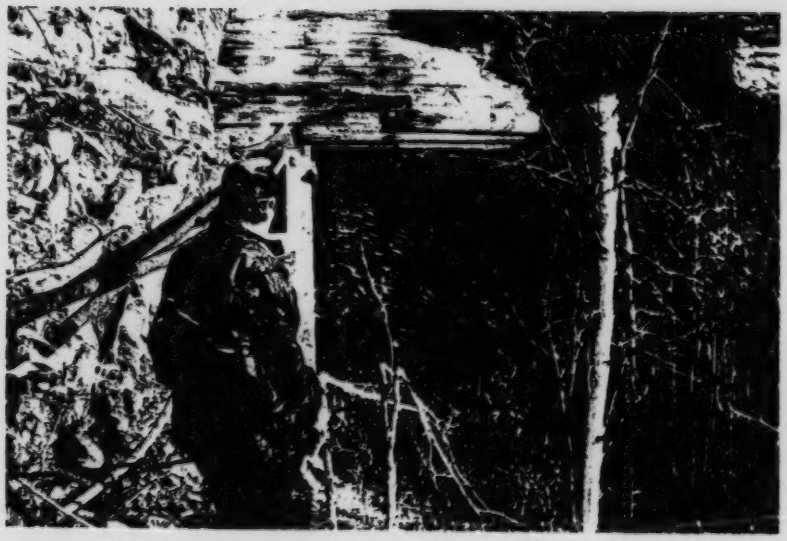
Photo 6.7-6 Nesbitt Mining and Exploration Adit
September 28, 2001

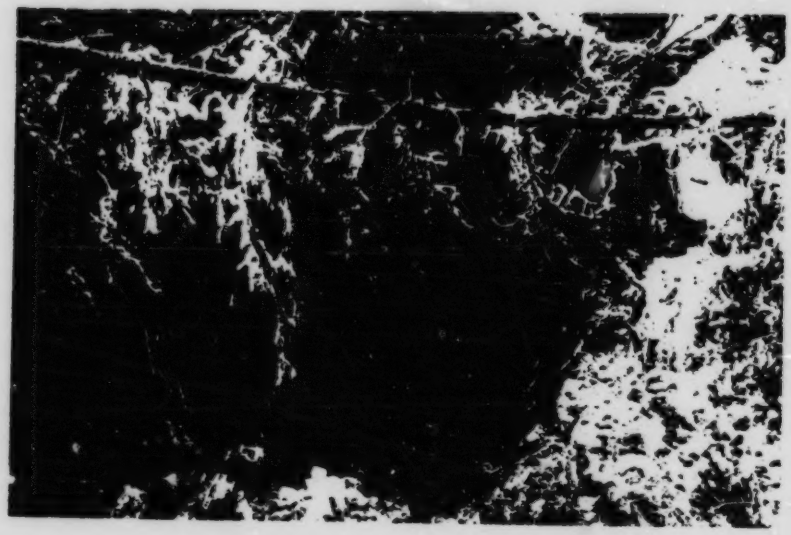
Photo 6.8-4 Baska Core Storage Area
September 29, 2001

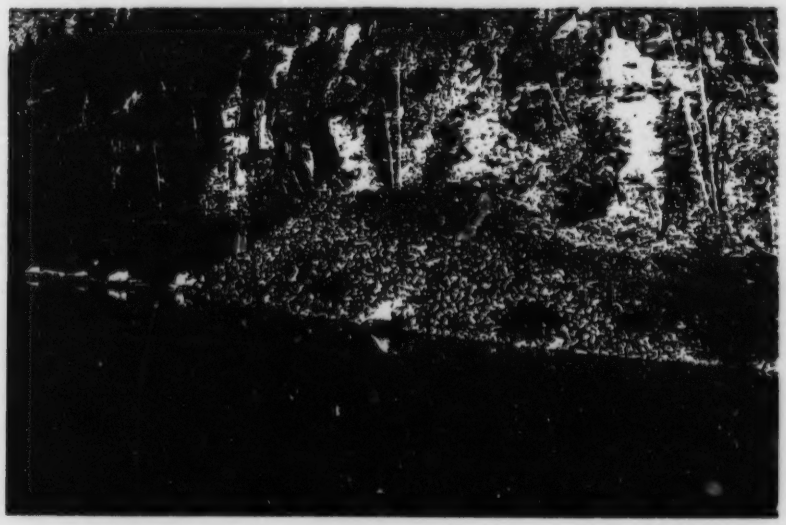
Photo 6.8-10 View of Main Waste Rock Pile
September 29, 2001

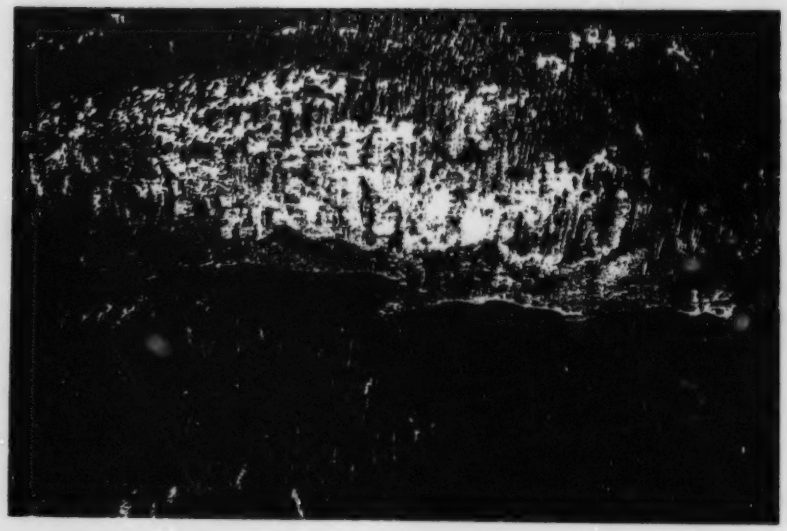
Photo 6.8-11 Aerial View of Baska Site
Looking Southwest
Septebmber 29, 2001

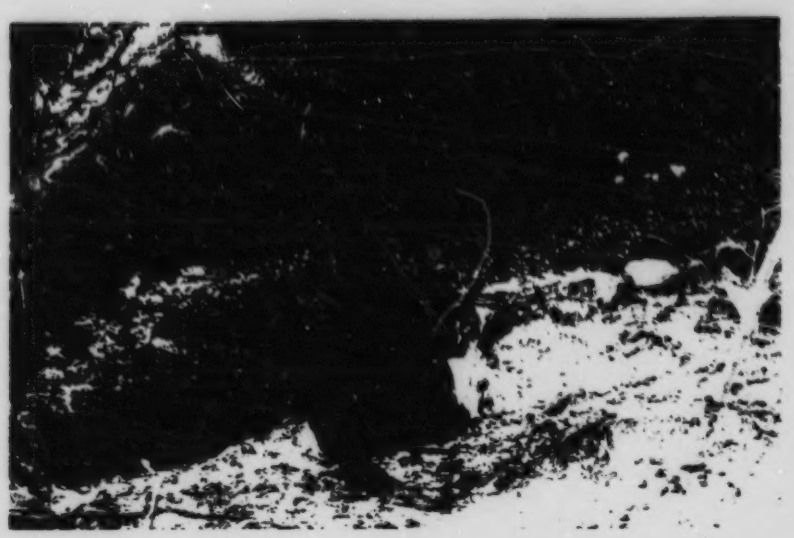
Photo 6.9-1 Consolidated Beta Gamma
Shaft Opening
September 29, 2001

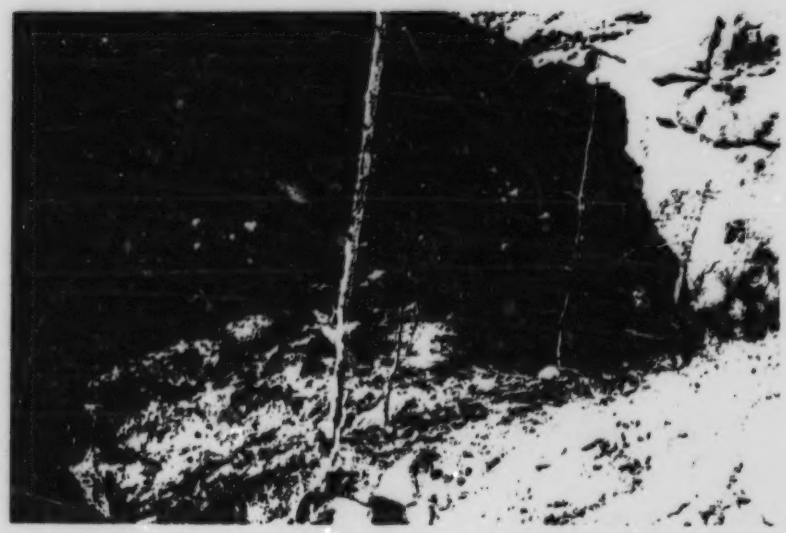
Photo 6.9-2 Consolidated Beta Gamma
Shaft Opening; Note Bridge of Rock
Between Shaft and Breakthrough to
Surface on Left of Photo
September 29, 2001

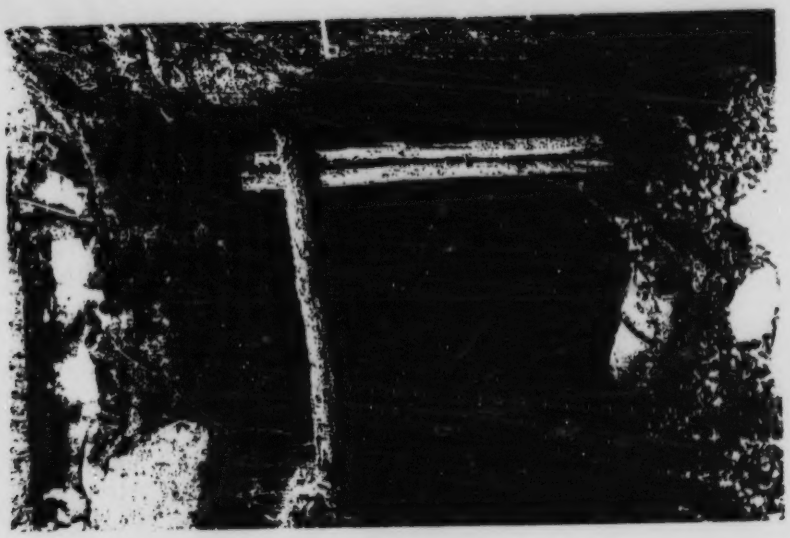
Photo 6.10-1 Gulch Adit
September 29, 2001

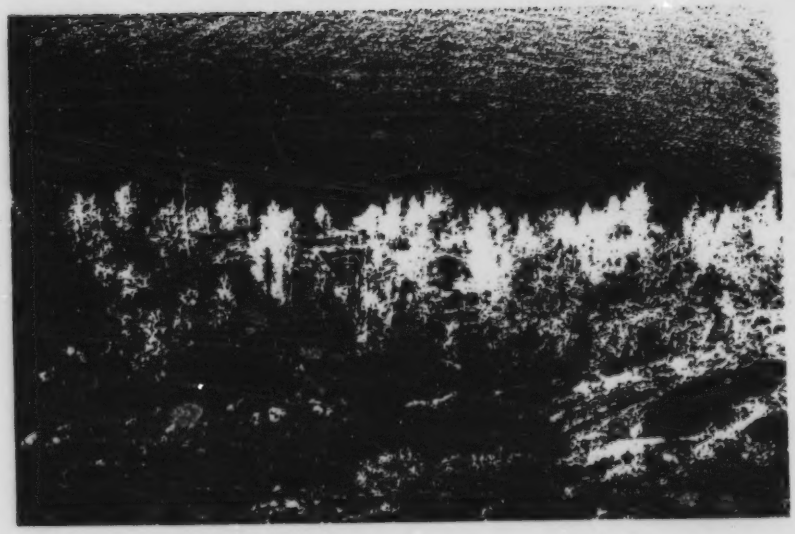
Photo 6.10-4 Wooden Debris near Shoreline
September 29, 2001

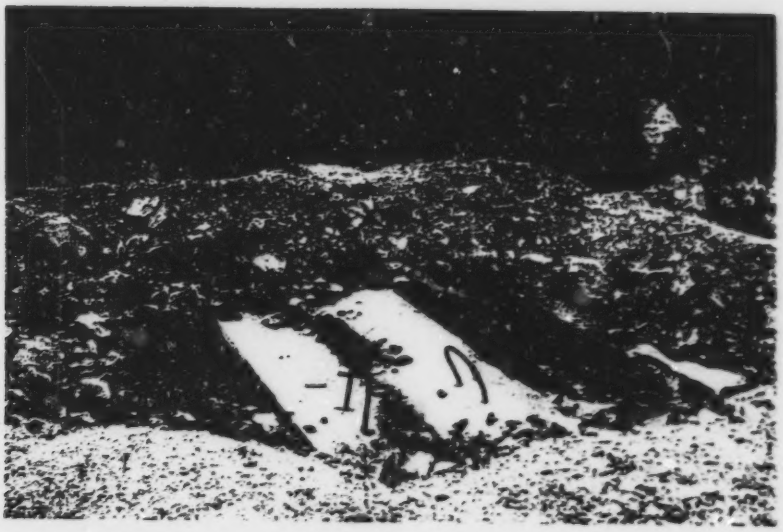
Photo 6.13-2 Consolidated Nicholson
Shaft No. 2 (Sealed)
October 01, 2001

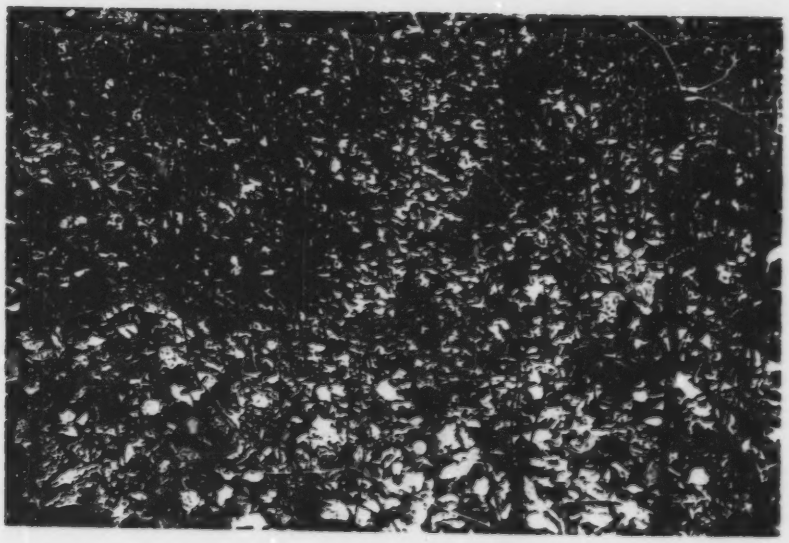
Photo 6.13-3 Consolidated Nicholson
Shaft No. 3 (Sealed)
Note Metal Handle on Concrete Cap in
Middle of Photo
October 01, 2001

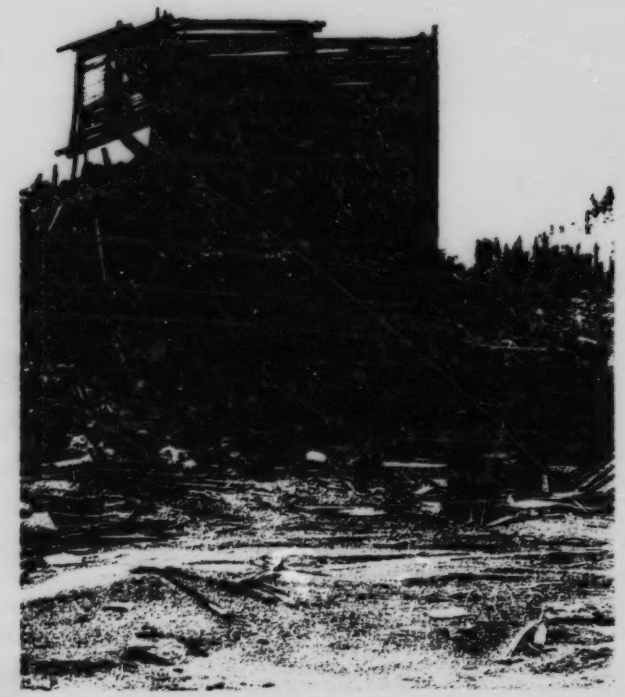
Photo 6.18-9 View of Open Pit Looking South
October 17, 2001

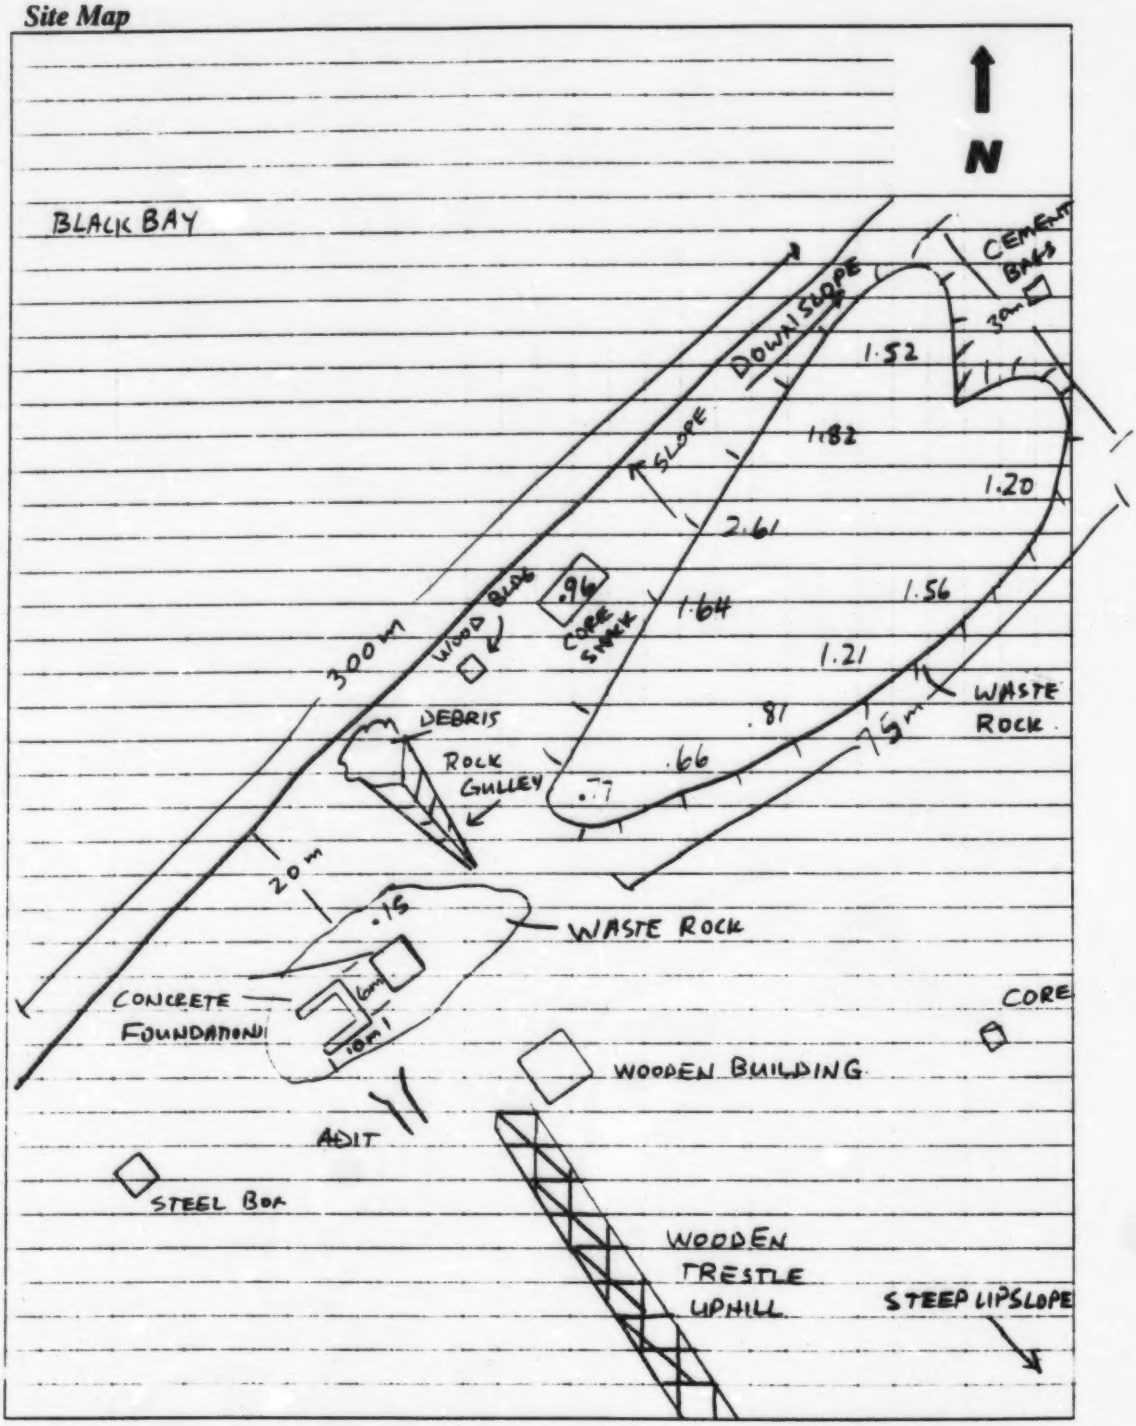
Scrap Material			
Type	Various		
Estimate Amount	SCC m^3		
Risk to Environment	***1 (low)*** 1	***2***	***3 (high)***
Risk to Wildlife	***1 (low)*** 1	***2***	***3 (high)***
Risk to Public Safety	***1 (low)*** 2	***2***	***3 (high)***
Residual Chemical on Site			
List Type	Cement		
Estimate Volume of Each	SC x SC lb bags		
Type of Storage	Bags		
Type of Containment (if any)	None		
Risk to Environment	***1 (low)*** 1	***2***	***3 (high)***
Risk to Wildlife	***1 (low)*** 1	***2***	***3 (high)***
Risk to Public Safety	***1 (low)*** 1	***2***	***3 (high)***
Mine Dewatering	Yes		
Locate Discharge if Possible	Discharge line led to Shaveline - Black Bay.		
Additional Comments	Assorted debris on site includes steel drums, steel rails, metal ore car, lumber, scrap wood, concrete formulations, Core Wooden trestle leading up slope.		
Other Information	Extensive amount of debris scattered about the site.

N
BLACK BAY
CEMENT BAGS
30m
DOWNSLOPE
1.52
SLOPE
1.82
1.20
2.61
1.56
1.64
.96
WOOD BLDG
CORE STACK
300m
1.21
WASTE ROCK
DEBRIS
.81
5m
ROCK GULLEY
.66
.77
20m
.15
WASTE ROCK
CONCRETE FOUNDATION
6m
10m
CORE
WOODEN BUILDING
ADIT
STEEL BOX
WOODEN TRESTLE UPHILL
STEEP LIPSLOPE
